Škoda Safety Day

ŠKODA SAFETY DEMONSTRATION

CRASH RESULTS

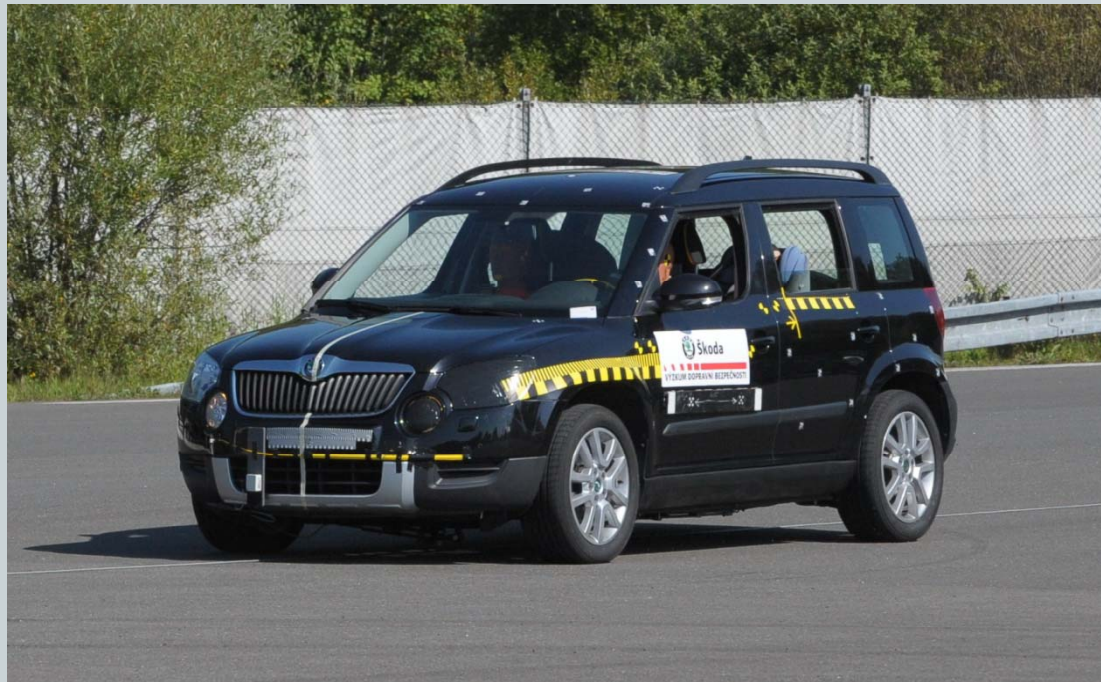
TECHNICAL SPECIFICATIONS - YETI

Car: Škoda Yeti 2.0 TDI, 6-speed manual gearbox

Occupants: Driver: HIII front passenger: HIII

Left rear passenger: P3 Right rear passenger: P1.5

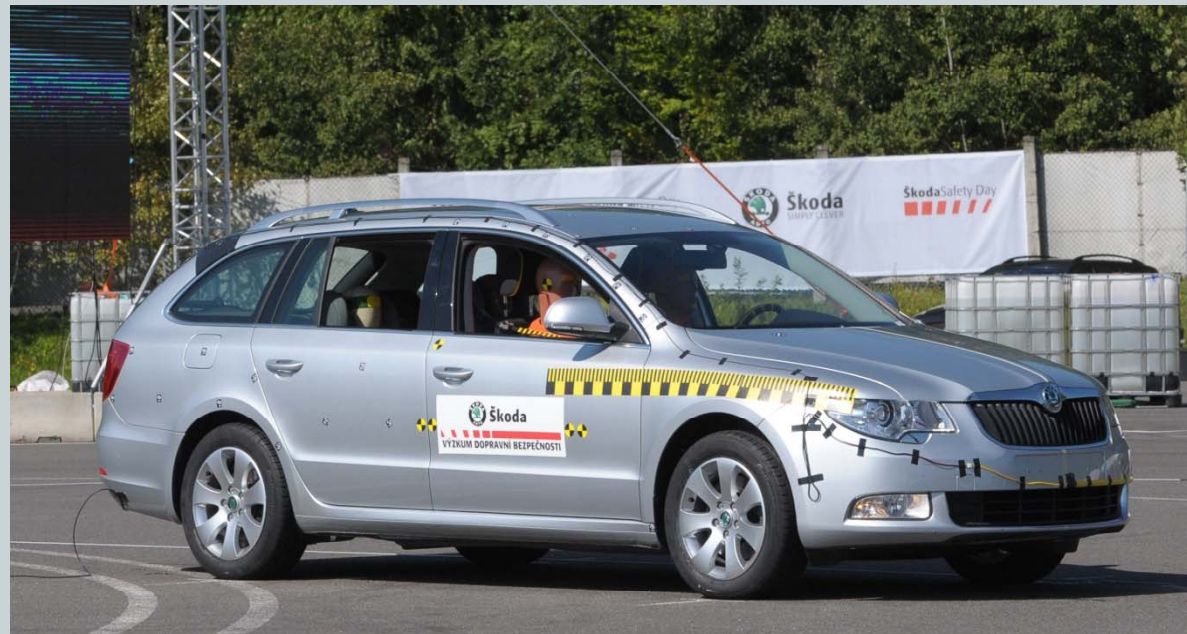
SUPERB COMBI

Car: Škoda Superb Combi, 2.0 TDI, 6-speed manual gearbox

Occupants: Driver: HIII, front passenger: HIII

Left rear passenger: P6, Right rear passenger: P3

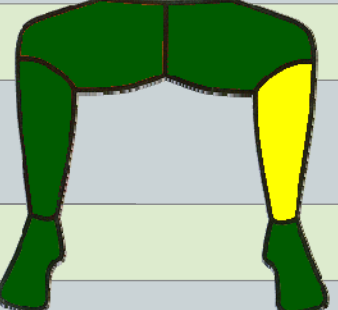
ASSESSMENT OF DUMMIES IN FRONT ACCORDING TO EURO-NCAP – ŠKODA YETI

HEAD + NECK

4.00
CHEST

4.00
PELVIS + THIGHS

4.00
SHINS

3.99
TOTAL	99.94%	15.99

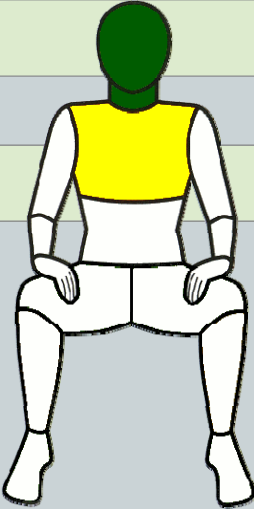
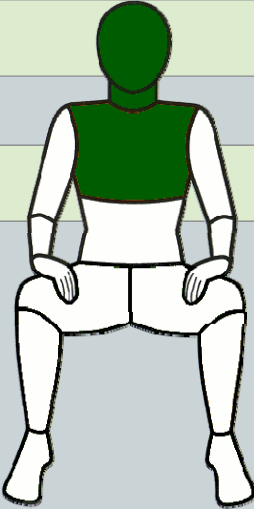
ASSESSMENT OF CHILD DUMMIES ACCORDING TO EURO-NCAP

HEAD + NECK	4.00

4.00
CHEST	2.91

4.00
TOTAL		93.19%	14.91

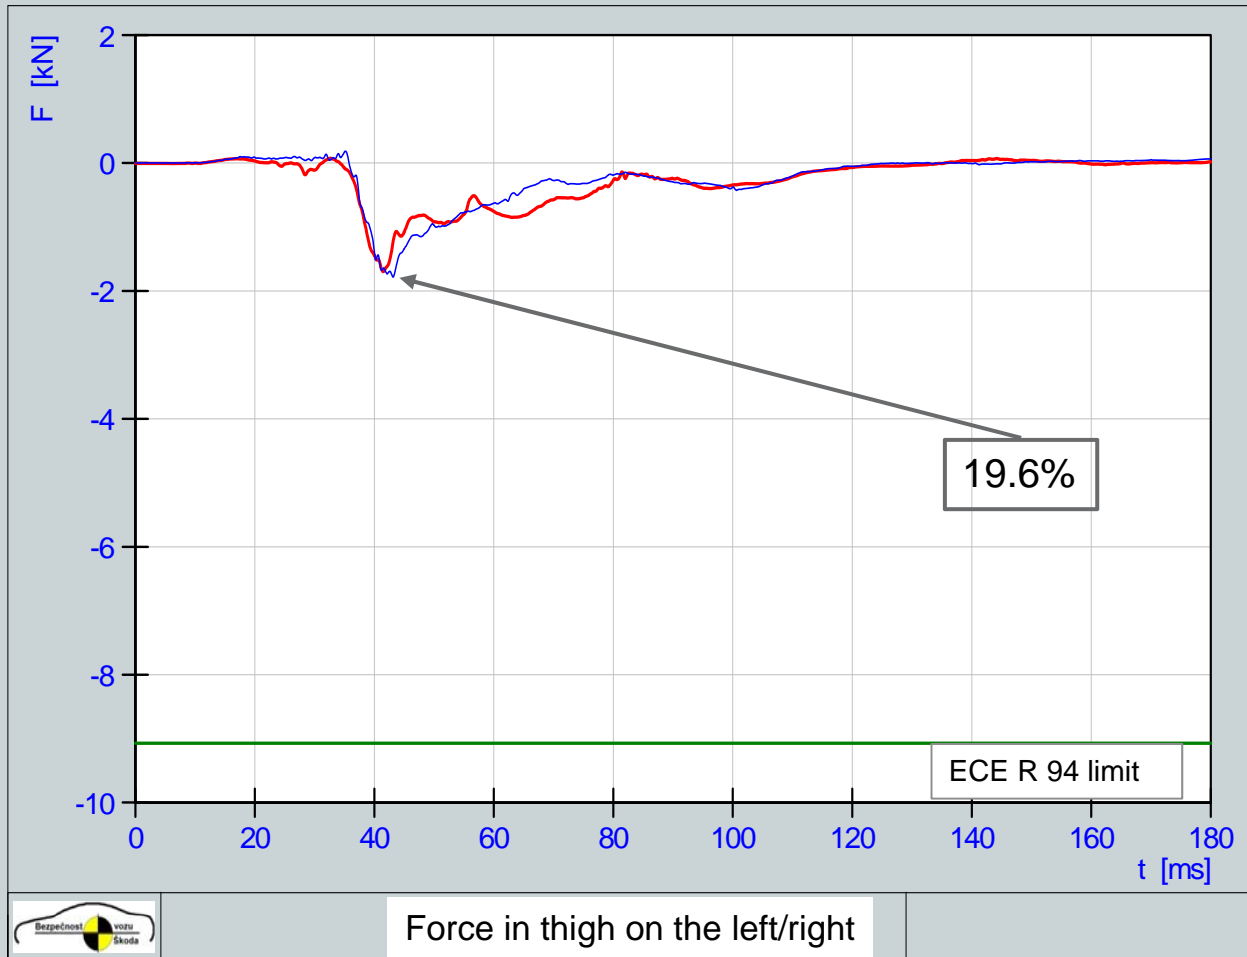
FORCE IN DRIVER'S THIGHS

Force in thigh on the left/right
